Highway Materials Research Laboratory  
132 Graham Avenue, Lexington, 29, Ky.

Re: Study of Acid Water Conditions in Kentucky

Re: Erosion of Longitudinal 40" Corrugated  
Metal Pipe, 1-1/2 Miles Northeast of  
Princess, Kentucky, on U. S. 60

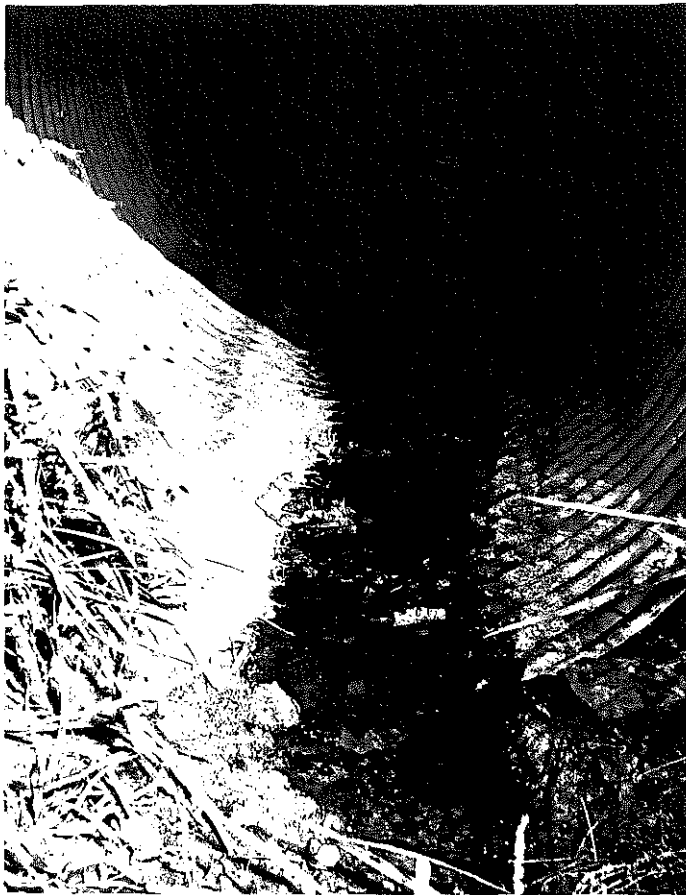
The results above are sufficient to explain the difference between the samples of drainage water and to explain the corrosion or erosion of the culverts on the north side of the road.

No. 1. Close-up of bottom of culvert on the north side of road. It can be seen that the bottom of the arc is missing and the water now flows at a depth of about 3" below the original pipe.

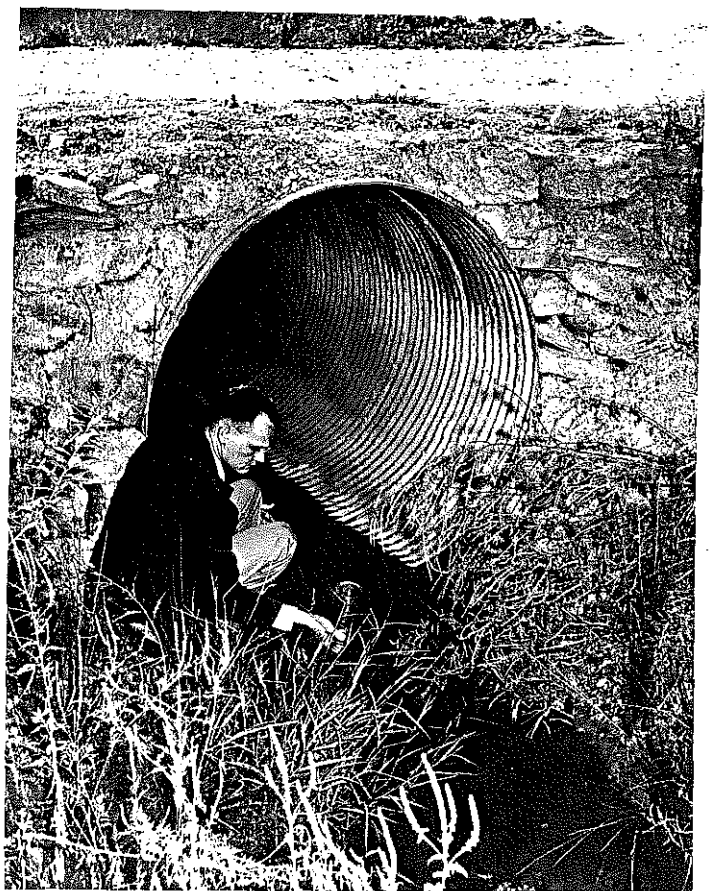
No. 2. General view of Culvert on south side of road showing Mr. Havens obtaining sample of the water. Culverts on this side show only slight corrosion and water still flows through them normally.
